LONG-TERM OPERATION OF AN AMB-SUPPORTED COOLANT PUMP IN A LIGNITE-FIRED POWER STATION - RESULTS AND OPERATIONAL EXPERIENCE -

Frank Worlitz and Torsten Rottenbach

Institute of Process Technology, Process Automation and Measuring Technology
University of Applied Sciences Zittau/Goerlitz, 02763 Zittau, Germany
ipm@hs-zigr.de

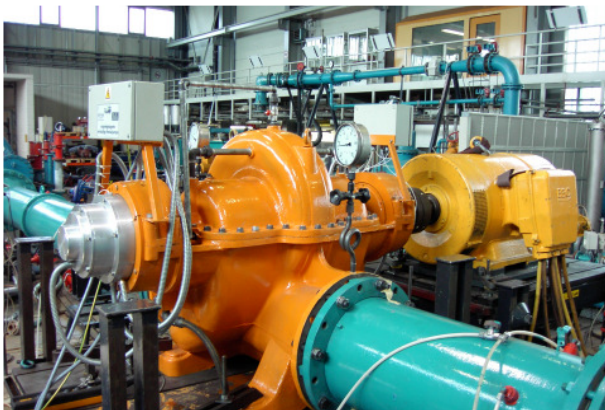
FIGURE 2: Pump in the flow-loop-test-bed at KSB

The testing on the test-bed showed that the magnetic bearings have mastered the pumping operations at the nominal working point without problems. When the delivery flow was throttled, axial loads beyond the design force of the axial magnetic bearing occurred, resulting in a safety shut-down of the pump. After pump modification – an axial magnetic bearing with a higher bearing load capacity was assembled – the pump was installed as the third fully adequate operational pump in the block-unit of the power plant. To realize this, the

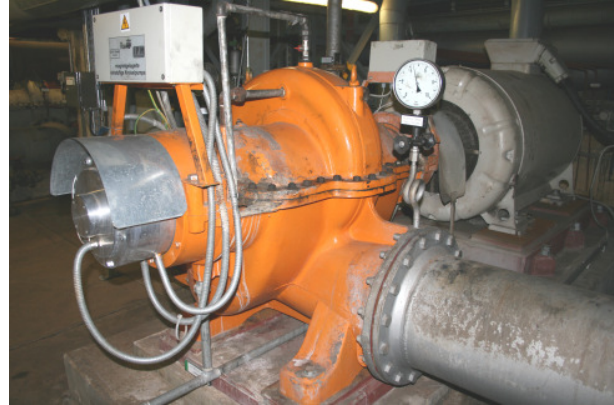
pump was integrated in the facility considering processing and controlling technology aspects. Figure 3 shows the pump in the power plant.

FIGURE 3: AMB-pump operating in the power plant

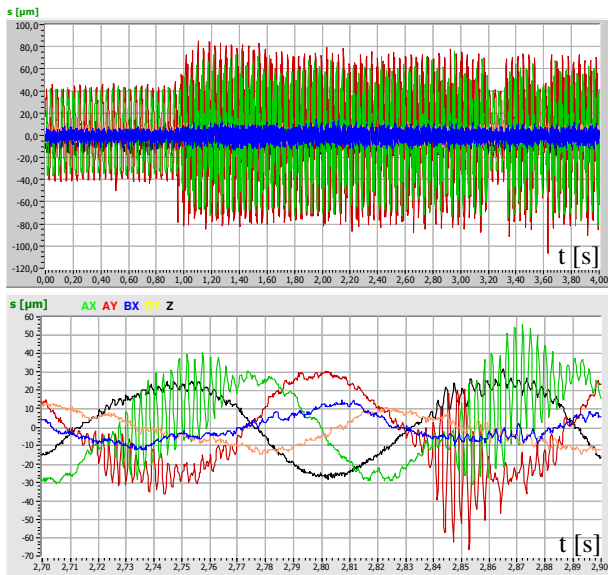
On the basis of shaft position signals, figure 6 shows the stochastic oscillations which occurred in the A-sided radial magnetic bearing in x- and y- direction (green and red lines) and the resonance vibrations interfere the shaft position signals on the A-side. These failures cannot causally be ascribed to alterations regarding the process parameters. Error detection in the functional chain sensors, signal processing, controlling electronics,

power electronics in the end located the failure in the mechanical part of the magnetic bearings.

FIGURE 6: Stochastic shaft vibrations (upper graph) and resonance (lower graph) during pump operation

- BX radial B-sided in x-direction
- BY radial B-sided in y-direction
- AX radial A-sided in x-direction
- AY radial A-sided in y-direction
- Z axial in Z- direction

When the pump was being commissioned in the power plant, an assembly error caused that a shaft nut from the rotor sheet package on the A-side loosened, resulting in severe resonance vibrations of the pump when running. These vibrations could be compensated over a period of time and partly attenuated, but in the end led to a safety shut-off.

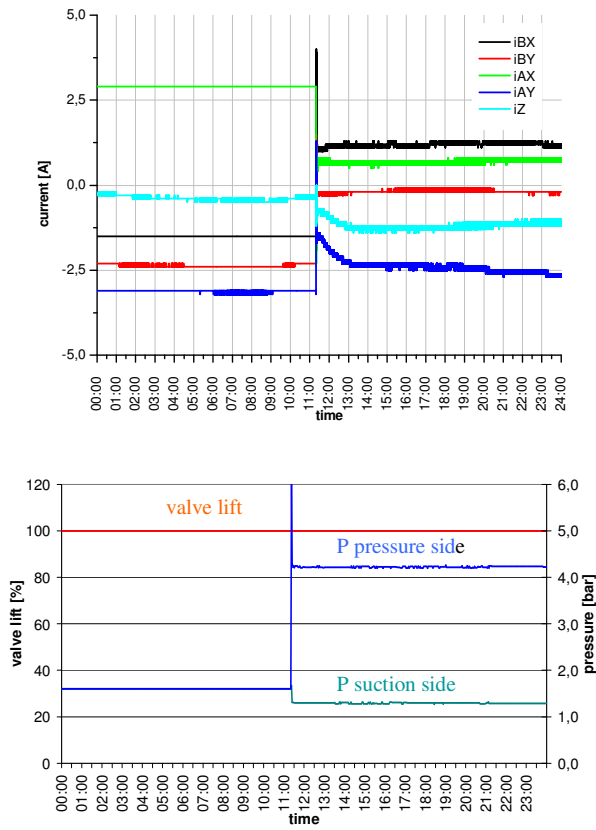
Figure 10 shows the commissioning of the pump from the operating mode reserve pump to the nominal working point on the basis of the data of bearing currents and pressure signals. The pump is connected at 11:22 a.m. with the regulating valve being opened to 100%. The pressure behind the pump rises from 1.6 bar to 4.22 bar, the pump pressure P decreases from 1.6 bar to 1.3 bar. After approx. 2 hours new thermal balance in the bearings has been reached, the bearing currents remain almost constant.

FIGURE 10: Bearing currents (upper graph) and pressures (lower graph) when pump is starting up to its nominal working point

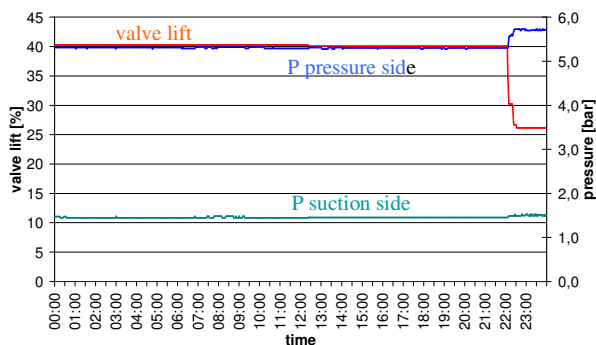
The delivery flow had to be strongly throttled due to weather conditions in order to keep the temperature in the cooling system stable, when the pump operating at a high nominal speed. Therefore the regulating valve was gradually shut from 40.3% to 26.7%, as shown in figure 11. As a result, pressure behind the pump increased from 5.31 bar to 5.72 bar with a possible maximum pressure of 6 bar.

FIGURE 11: Regulating valve position and pressures with strongly choked delivery flow

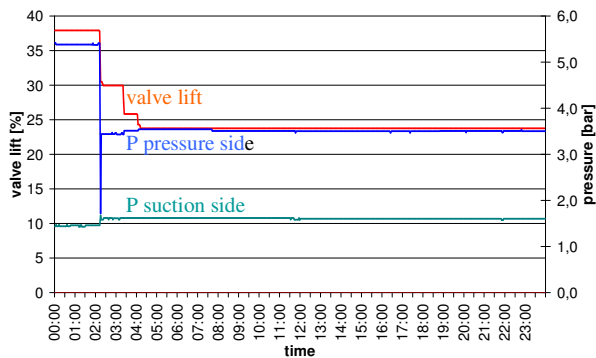
Because of a low energy requirement the block operation system-inherently had to be transformed into mono-unit operation due to. As a consequence, the required cooling capacity decreases. So the pump was switched from high-speed operation to low-speed operation, cp. table 1. Figure 13 shows valve position and pressures before and after switching.

FIGURE 13: Pressures and regulating valve position with speed switching

Initially, the pump is working with a high speed at a regulating valve position of 37.9% and a pressure of 5.38 bar. About 2:15 a.m. the pump is switched to the lower rotational speed. Thus the pressure temporarily falls to the level of the pressure on the suction side. Simultaneously the regulating valve is phased down to 30.5%. Figure 14 displays the A-sided radial shaft position when switching. It is clear from the figure that the pump had to be shortly shut down for switching. At a time of 0.8 s the engine is shut off, at 4 s the non-return valve is shut. Then the shaft gradually comes to a stop in its magnetic bearings. At a time of 31.75 s the low-speed pump is connected. After that the valve phases down to 23.7%, pressure reaches 3.5 bar.

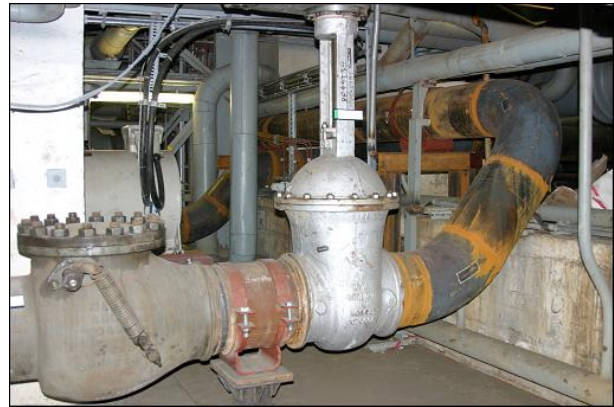
When switching off, the pump is separated from the pressure side of the cooling circuit by a swing-type check valve. For repair works on the pump, additional gate valves separating the aggregate safely from the cooling system have been inserted in the suction and pressure lines. Figure 15 shows the non-return valve and the slider on the pressure side of the pump.

FIGURE 15: Non-return valve and slider in the pressure line

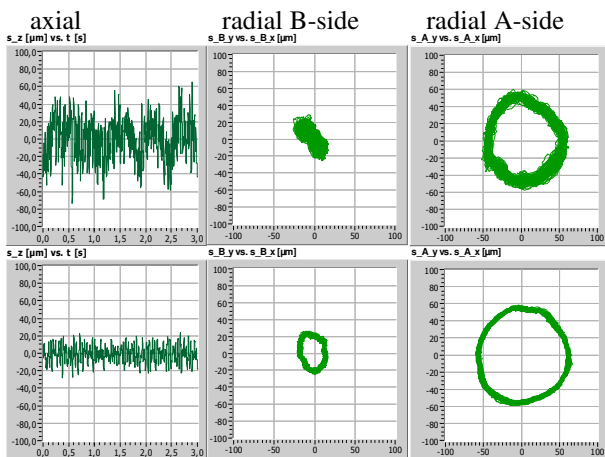
Figure 19 shows the orbits of radial shaft positions and the axial shaft position signal approx. 10 s after connection and when the slider is fully open.

FIGURE 19: Shaft positions at slider opening and with fully opened slider

During the start-up process the shaft vibrates considerably more than when the pump is in steady operation. Furthermore, the B-sided orbit is clearly deformed. Axial deviation reaches values of over 70 μm , in steady operation it is approx. 20 μm .

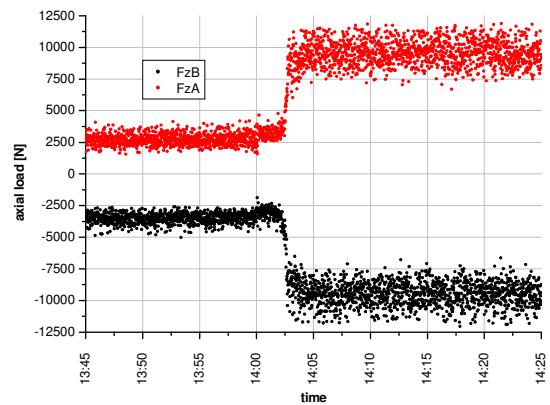
A more continuous and an even heavier load compared to a start-up against the shut slider is the parallel operation of two pumps. They simultaneously pump into the cooling system with a pressure of over 6 bar. Fig. 20 shows the axial bearing loads before and when the second pump operates parallel. The average values of load FzA increase from 2800 to 9450 N, average values of load FzB from -3500 to -9400 N. The highest peak demands are 11900 N and -12050 N. They are controlled by the axial magnetic bearing [1].

FIGURE 20: Axial bearing loads during parallel pump operation
