Revision of the AMB-Supported Coolant Pump after the Long-Term Operation in the Power Plant

Abstract: Within a research project the conventional bearing system of a cooling water booster pump was substituted with active magnetic bearings (AMBs). This AMB-supported pump was installed and tested in the inter-cooling circuit of a 500 MW block-unit in a lignite power station as a demonstration plant. The aim was to prove the suitability of magnetic bearings for using on turbo machines under operation conditions in a power station [1]. After the phase of commissioning the pump was used in a long term operation as the main operation pump [2]. The pump was subjected to a revision after an approx. three and a half year running time. Thereby the condition of the pump, especially of the bearing components was checked. The disassembling of the pump was covered by some difficulties, caused by corrosion of mechanical parts. In addition with detected damages on single components, countermeasures for prevention had to be derived. Furthermore design criterions, applicable materials and requirements e. g. for the shaft seals can be concluded. This report gives an insight into the increase of exper

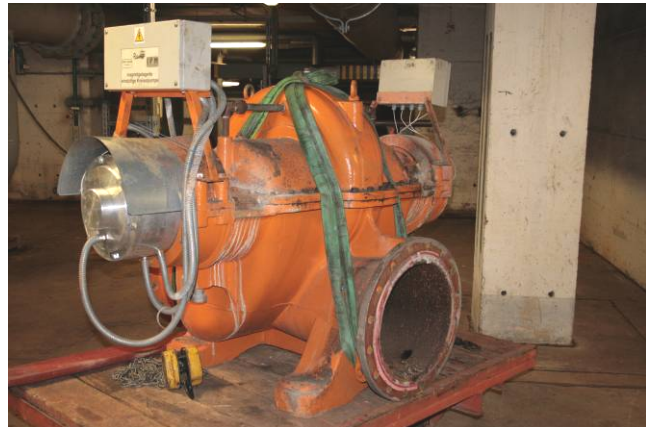
For its revision the pump was dismantled from the plant. An on-site inspection was not possible as the pump had to be dismantled. Fig. 2 demonstrates the dismantled pump, prepared for its transportation to the workshop.

These components were maintained, repaired respectively renewed due to their condition. *Fig. 2: AMB supported coolant pump after long term operation*

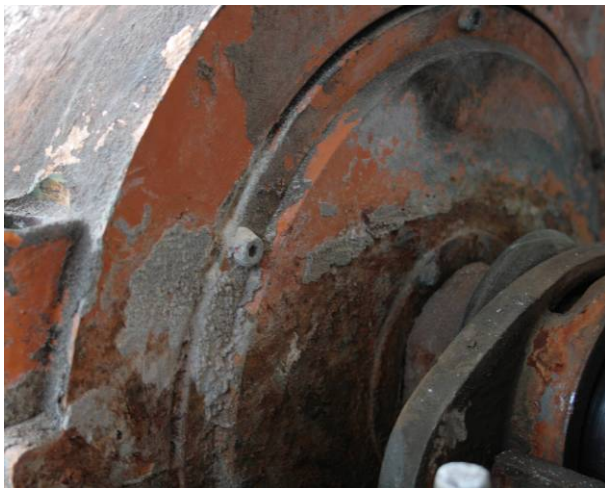
Bearing housing. The permanently occurring leakage at the shaft seals resulted in substantial deposits on the housings of bearings and the pump. These deposits obstructed the parting lines between the bearing housing and the pedestals and impeded the disassembling. The ever-present moisture by the slightly alkaline leakage water (pH = 8,5) resulted in a considerable corrosion in the sphere of influence (interaction with atmospheric oxygen). Fig. 3 exemplarily demonstrates the deposits on the bearing cover with secondary touch down bearings and pitting corrosion on the bearing housing.

Fig. 3: Deposits and pitting corrosion on the bearing housing

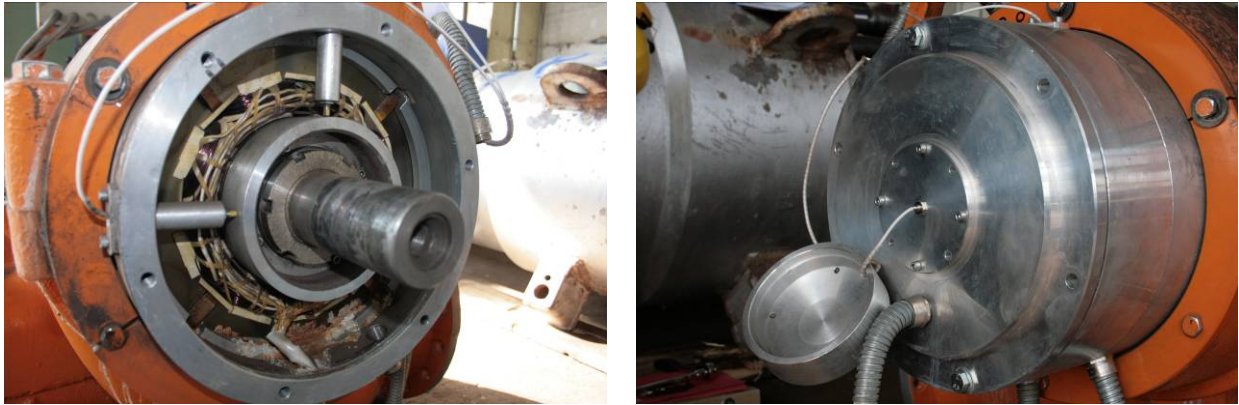
Radial and axial position sensors. The position sensors of the AMBs are located out of reaching for leakage in direction to the shaft ends. Fig. 4 shows the driven-end-sided (DE) measuring system for the determination of the radial shaft position. The bearing cover was dismantled here. There is one eddy current sensor per x- and y-axis used. The right picture shows the axial position sensor. It measures against a sensor plain on the non-driven-end-sided (NDE) shaft end. In the levels of the measuring systems there were no damages due to deposits, corrosion or mechanical contact detected.

Fig. 4: DE-sited radial measuring system for shaft position and axial position sensor

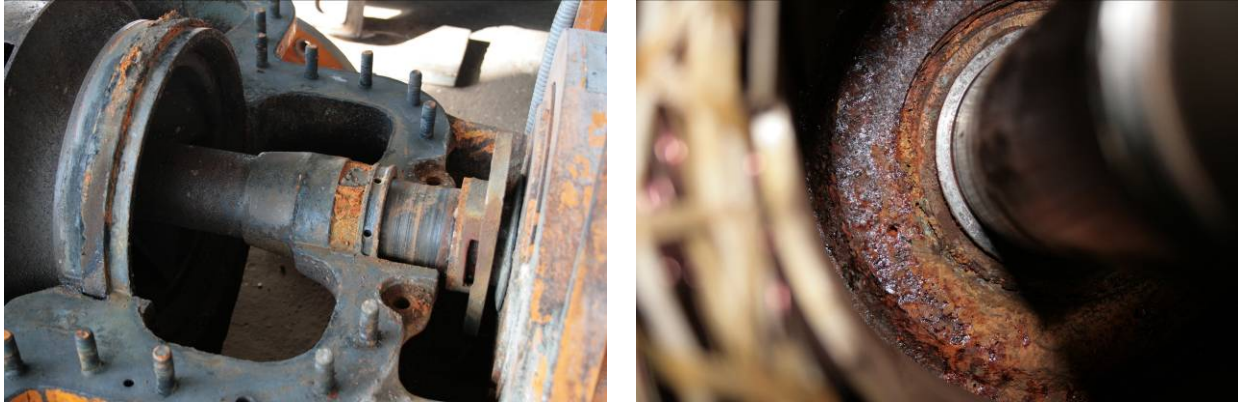
Touch down bearings. The touch down bearing system at the pump is subdivided into the primary and the secondary radial touch down bearings and the axial touch down bearing. As primary radial touch down bearings the basic bushings of the shaft seals are used as water lubricated gliding bearings – compare Fig. 1. Grooved ball bearings are additional integrated in the bearing covers as secondary touch down bearings. They are used to avoid mechanical contact of rotor and stator parts of the radial magnetic bearings. Thrust rings that are

mounted in the ring magnets form the axial touch down bearings. Fig. 6 shows the shaft in a sliding bush and a grooved ball bearing inside a bearing cover.

Fig 6: Primary and secondary radial touch down bearings

Measurements at the basic bushings had shown an abrasion of approx. 250 μm that required the exchange of the two basic bushings. These abrasions occurred in the phase of commissioning. The advanced corrosion at the grooved ball bearings as well required a replacement.

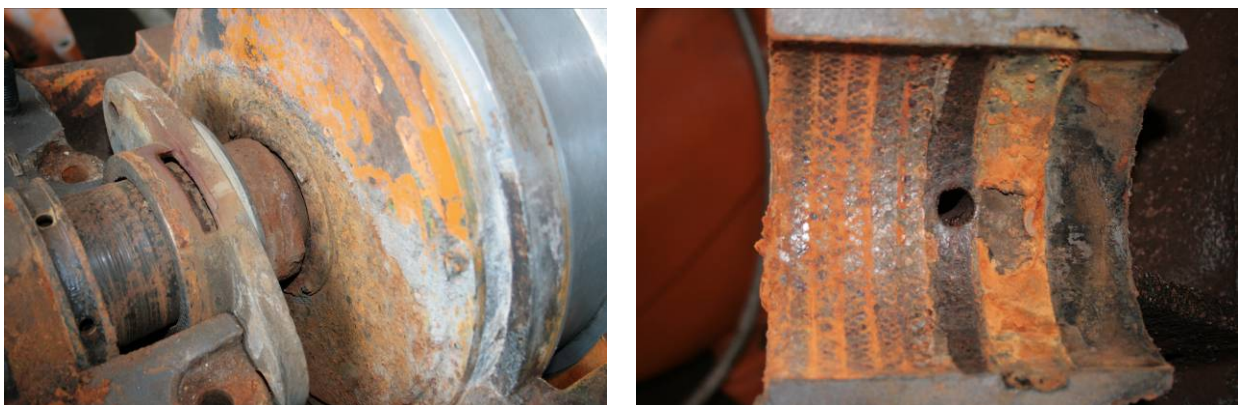
Shaft seals and pump casing. During the period of operation there was ever increasing leakage at the shaft seals. These could be reduced, neither by readjusting the stuffing box nor by new packing. The reason was the operational wear in the area of the shaft seals. At the shaft sleeves it came to abrasions due to the permanent friction between the shaft sleeves and the packing, like the brush marks shown in the left of Fig. 7. In the right picture corrosion and wear marks can be recognized in the stuffing box area of the pump cover. Thus the surface roughness in this area increases and leads to leakage between the packing and the pump cover. This area was newly bushed.

Fig 7: Wear in the area of the shaft seals at the shaft sleeve and in the pump cover
